# **Superfund Five-Year Review Report**

AmeriSteel Indiantown Mill Formerly known as Florida Steel Corporation Indiantown, Martin County, Florida

Prepared for U.S. Environmental Protection Agency, Region IV December 2000

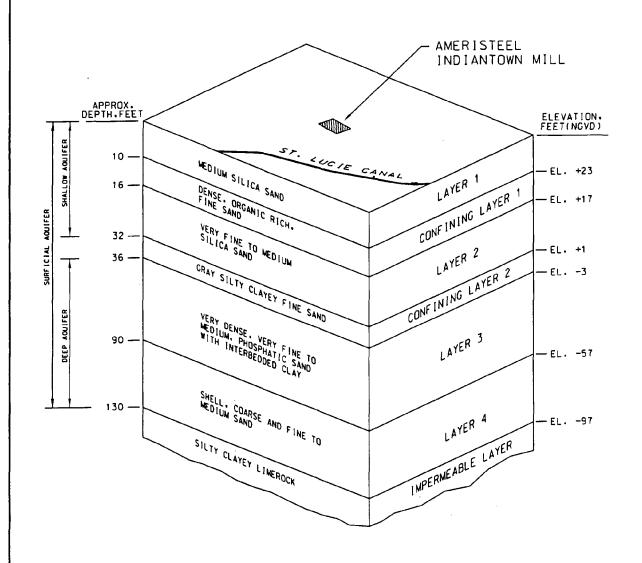
Site Geology Figure 4

The hydrogeological system at the site is depicted in Figure 4 and can be generalized as four aquifer units and two aquitards (i.e. leaky confining layers). Brief descriptions of these layers in descending order from ground surface to the bottom of the surficial aquifer are as follows:

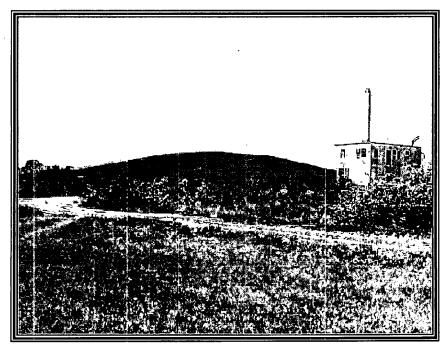
27 April 2000 Photograph #1

Location: Florida Steel Corporation, Martin County Site, Indiantown, Florida. Description: Indiantown Mill Vault

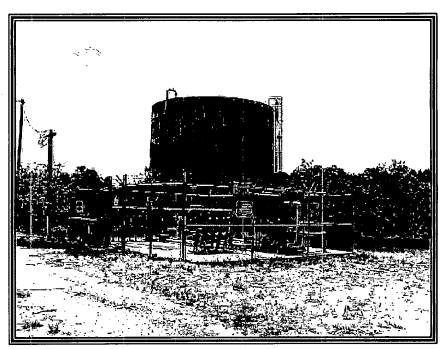
27 April 2000 Photograph #2

Description: Treatment Facility and Well Manifolds with 300,000-Gallon Tank in the Background

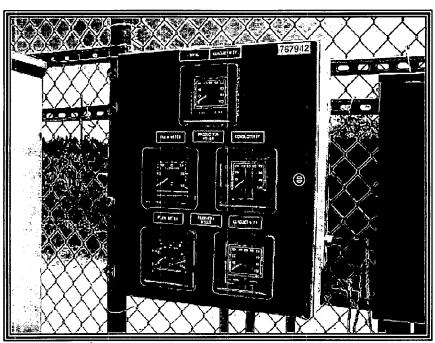
27 April 2000 Photograph #4

**Location:** Florida Steel Corporation, Martin County Site, Indiantown, Florida. **Description:** Flow and Conductivity Meters Panel

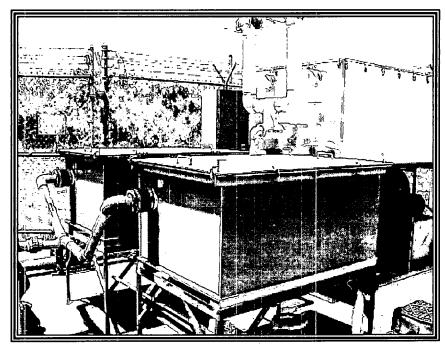
Photograph #5
Location: Florida Steel Corporation, Martin County Site, Indiantown, Florida.
Description: Iron Filtration Units 27 April 2000

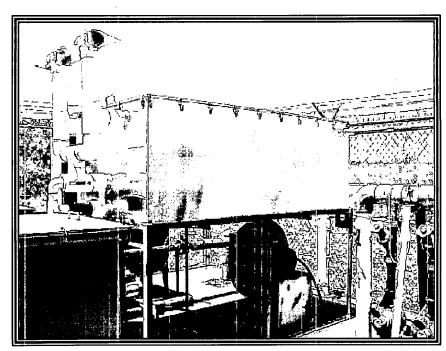
Photograph #6
Location: Florida Steel Corporation, Martin County Site, Indiantown, Florida.
Description: Aeration Tank 27 April 2000

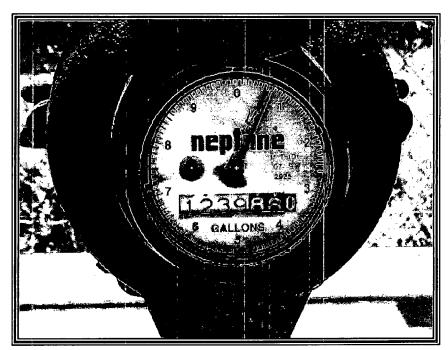
27 April 2000 Photograph #7

Location: Florida Steel Corporation, Martin County Site, Indiantown, Florida. **Description:** Flow Meter

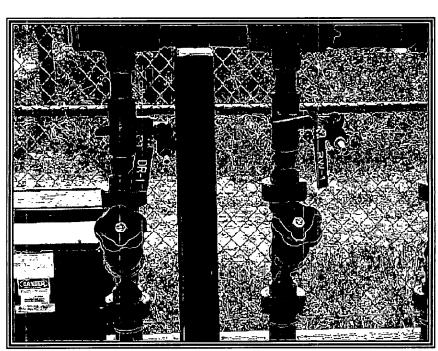
27 April 2000 Photograph #8

**Location:** Florida Steel Corporation, Martin County Site, Indiantown, Florida. **Description:** Recovery Well Manifold

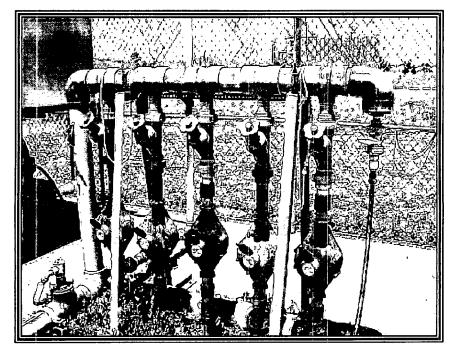
Photograph #9
Location: Florida Steel Corporation, Martin County Site, Indiantown, Florida.
Description: Recovery Well Manifold 27 April 2000

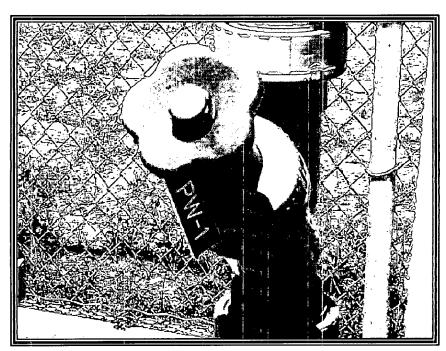
Photograph #10 Location: Florida Steel Corporation, Martin County Site, Indiantown, Florida. Description: Production Well Manifold 27 April 2000

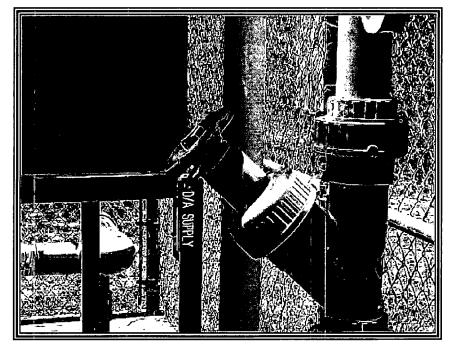
27 April 2000 Photograph #11

**Location:** Florida Steel Corporation, Martin County Site, Indiantown, Florida. **Description:** Production Well Manifold

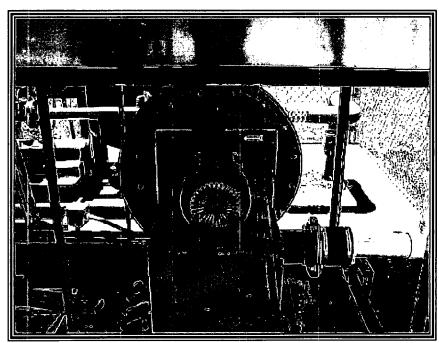
Photograph #12 27 April 2000

**Location:** Florida Steel Corporation, Martin County Site, Indiantown, Florida. **Description:** Blower for Aeration Tank

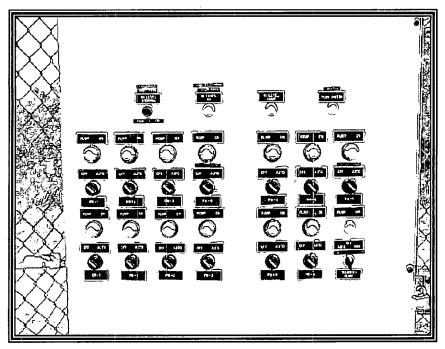
Photograph #13

Location: Florida Steel Corporation, Martin County Site, Indiantown, Florida. Description: Control Panel for Groundwater Remediation System

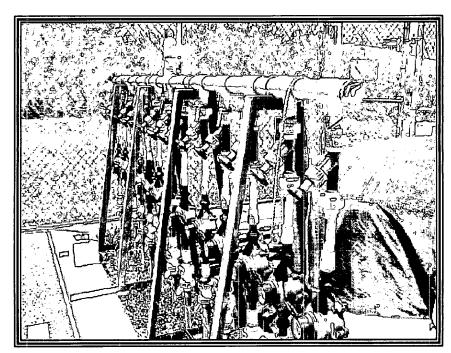
Photograph #14 27 April 2000 Location: Florida Steel Corporation, Martin County Site, Indiantown, Florida.

**Description:** Injection Well Manifold

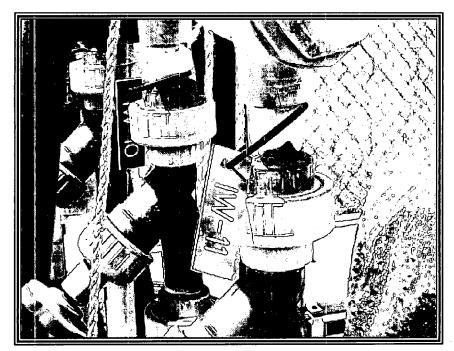
Photograph #15 Location: Florida Steel Corporation, Martin County Site, Indiantown, Florida. Description: Injection Well Manifold 27 April 2000

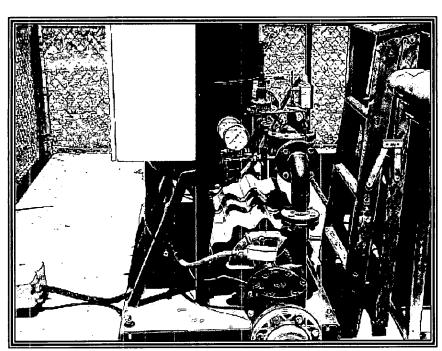
27 April 2000 Photograph #16

Location: Florida Steel Corporation, Martin County Site, Indiantown, Florida. Description: Irrigation Pump Station

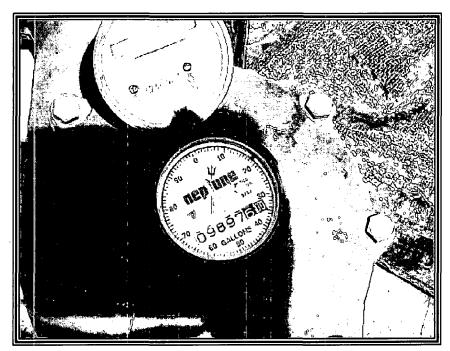
Photograph #17 Location: Florida Steel Corporation, Martin County Site, Indiantown, Florida. Description: Flow Meter 27 April 2000

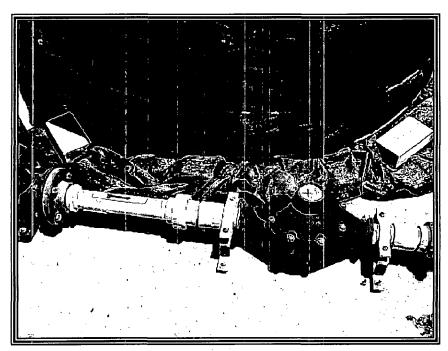
27 April 2000 Photograph #18

**Location:** Florida Steel Corporation, Martin County Site, Indiantown, Florida. **Description:** In-line Flow Meter

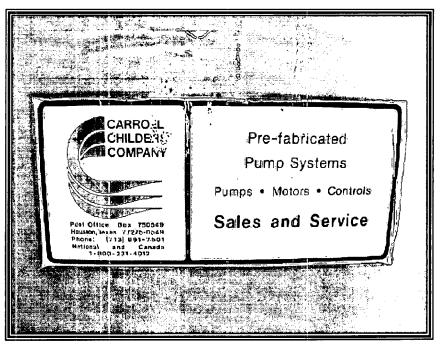
Photograph #19 27 April 2000

**Location:** Florida Steel Corporation, Martin County Site, Indiantown, Florida. **Description:** Irrigation Pump

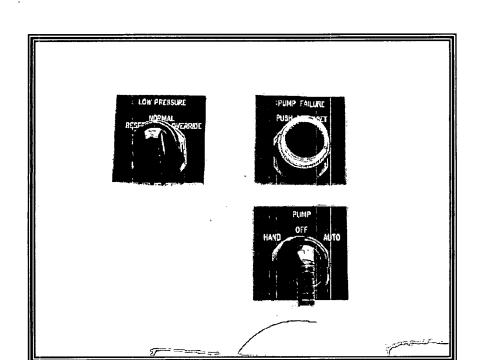
Photograph #20 27 April 2000

**Location:** Florida Steel Corporation, Martin County Site, Indiantown, Florida. **Description:** Irrigation Pump Control

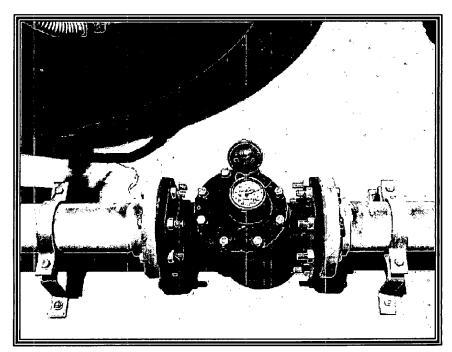
Photograph #21 Location: Florida Steel Corporation, Martin County Site, Indiantown, Florida. Description: Flow Meter 27 April 2000

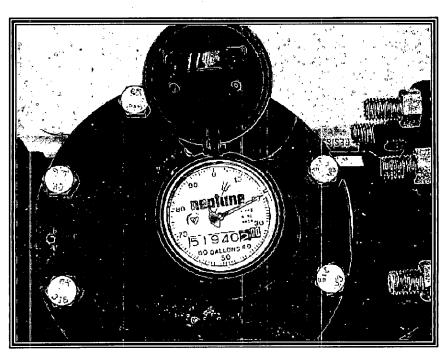
Photograph #22 Location: Florida Steel Corporation, Martin County Site, Indiantown, Florida. 27 April 2000

Description: Flow Meter

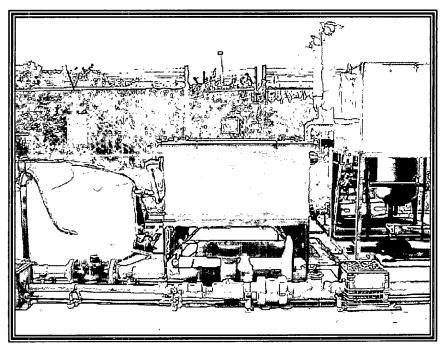
Photograph #23 27 April 2000

**Description:** Iron Filtration Units

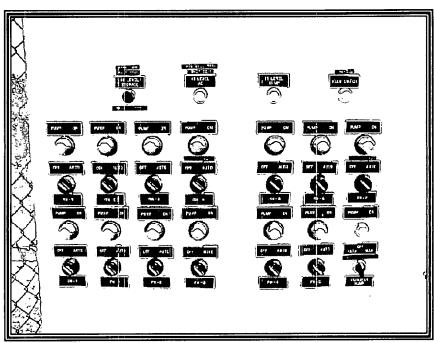
Photograph #24 27 April 2000

**Location:** Florida Steel Corporation, Martin County Site, Indiantown, Florida. **Description:** Control Panel for Groundwater Remediation System

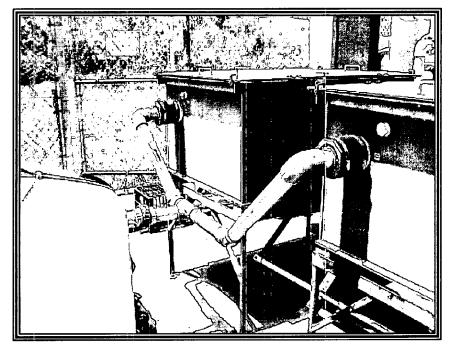
Photograph #25 27 April 2000

Location: Florida Steel Corporation, Martin County Site, Indiantown, Florida. Description: Iron Filtration Unit Manifold and 500-gallon Storage Tank

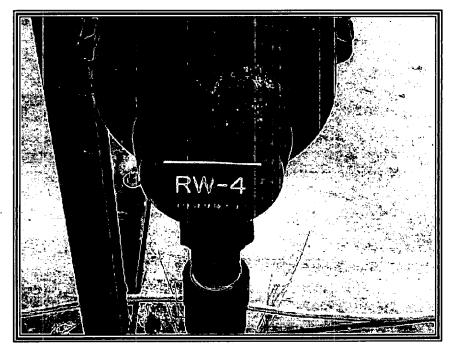
27 April 2000 Photograph #27

**Location:** Florida Steel Corporation, Martin County Site, Indiantown, Florida. **Description:** Recovery Well Manifold

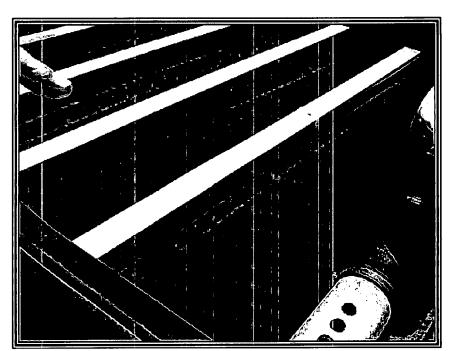
27 April 2000 Photograph #28

**Location:** Florida Steel Corporation, Martin County Site, Indiantown, Florida. **Description:** Iron Filters

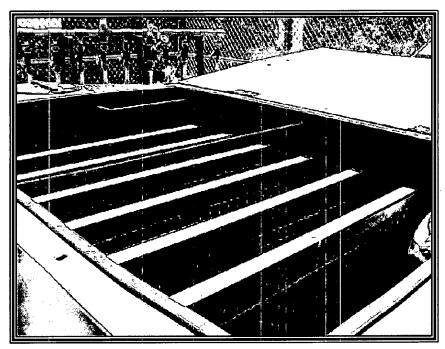
Photograph #29 27 April 2000

**Description:** Iron Filters

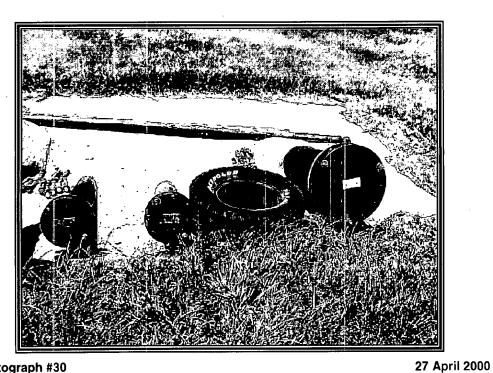
Photograph #30
Location: Florida Steel Corporation, Martin County Site, Indiantown, Florida.
Description: Leachate Collection/Leak Detection Pipes and Cleanouts

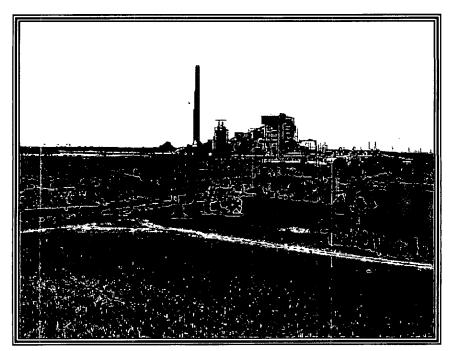
27 April 2000 Photograph #32

**Location:** Florida Steel Corporation, Martin County Site, Indiantown, Florida. **Description:** Remediation Southwest Wetland

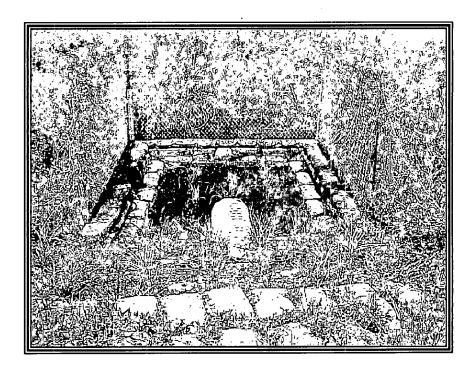
Description: Culvert that Conveys Water off AmeriSteel Property into Southwest Wetland 27 April 2000

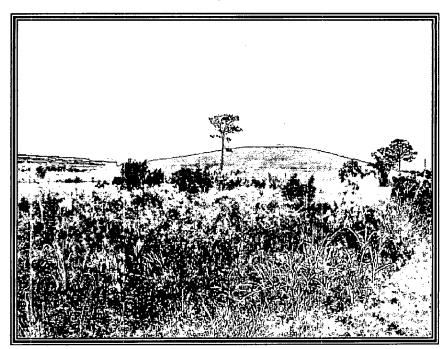
Photograph #35 Location: Florida Steel Corporation, Martin County Site, Indiantown, Florida. Description: Indiantown Mill Vault 27 April 2000

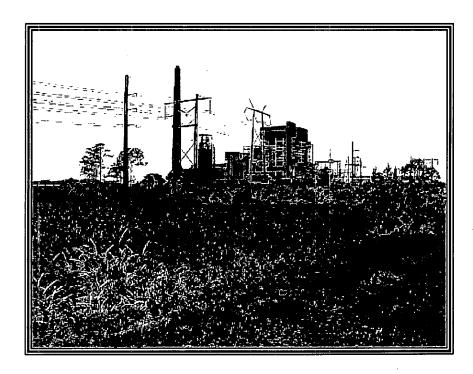
Photograph #37
Location: Florida Steel Corporation, Martin County Site, Indiantown, Florida.
Description: Remediated Southwest Wetland 27 April 2000
